Effect of severe hurricanes on Biorock Coral Reef Restoration Projects in Grand Turk, Turks and Caicos Islands

Lucy Wells¹, Fernando Perez¹, Marlon Hibbert¹, Luc Clerveaux¹, Jodi Johnson¹ & Thomas J. Goreau²

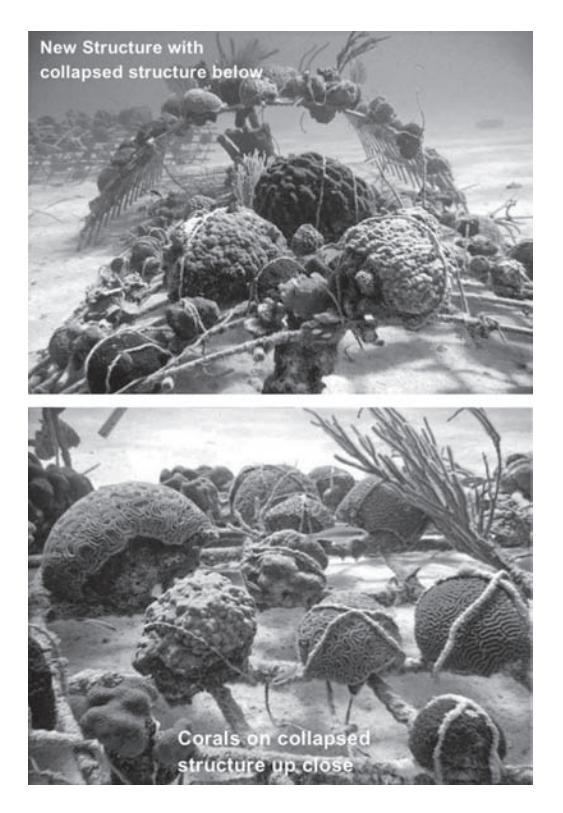
After the hurricanes the Governor's Beach structure was fully erect since the waves passed straight through with little damage. The Oasis structures, tie-wired rather than welded, had one module sag open in place (since replaced with a new, welded structure). However this structure was still intact, and when rewired, the corals continued to grow on it (Fig. 3). The projects lost about 30% to 40% of corals due to the hurricanes. Most of those lost had only been wired a few days before and had not yet attached themselves firmly. However, high coral survival and low structural damage after hurricanes indicate that Biorock reef restoration can be effective in storm-impacted areas. Photographs of both projects before and after the hurricanes are shown in Fig. 4 and Fig. 5.

Fig. 4. Oasis Projects, before and after hurricanes, in July and October 2008. Photos by Mike Reimers.

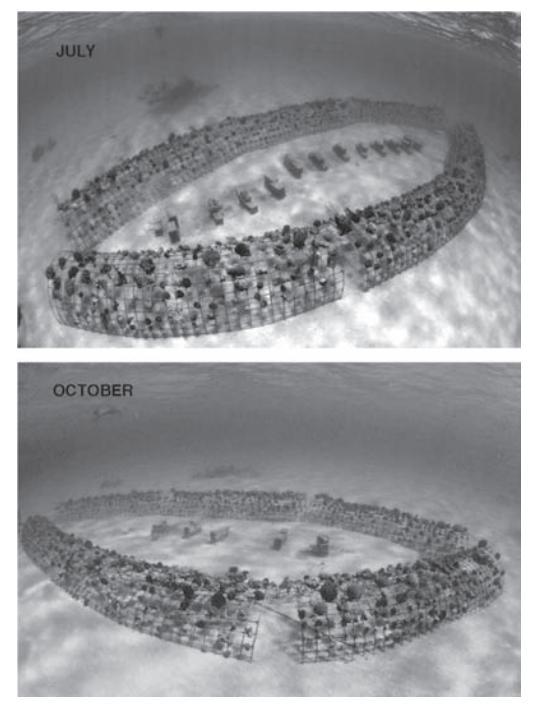
Fig. 5. Governor's Beach Projects, before and after hurricanes, in July and October 2008. Photos by Mike Reimers.

Governor's Beach structures, which shallower and closer to shore, would have been expected to have more physical wave damage, but had little or none. The Oasis structures had one module sag. These structures at Oasis had not been welded, they had simply been hand tied with binding wire. This project received very little power for the first year due to repeated breakage of the cables by dragging anchors, until the area was made a No Anchor Zone. During extended periods of no power, binding wire did not receive complete protection from rusting by the electrical current, and many binding wires rusted and fell off. Nevertheless only one of the four structures sagged. The reason for the very minor physical damage is almost certainly that these structural volumes are more than 99% water, so waves passed right through the structures with minimal drag forces. That might not have been the case had they had flat closed surfaces. The fact that these structures were severely undercharged implies that faster growing structures would have had even less damage. Accretion and coral growth could be further increased by delivering more power to the structures.
