# The 22 April 1991 Limón, Costa Rica tsunami field survey

**ABSTRACT:** A small tsunami (tsunami magnitude,  $m \sim 1$ ) was observed following the 22 April 1991 Mw 7.7 Limón, Costa Rica earthquake along the Caribbean coast of Costa Rica and Panama. This report summarizes eyewitness observations from 26 sites along 150 km of affected coast from Río Matina, Costa Rica to Bocas del Toro, Northwestern Panama, as well as tide gauge recordings from Panama, Puerto Rico and the Virgin Islands. No emergency warnings were issued before the tsunami occurred. While little or no tsunami-related property damage was reported, two or more drownings were attributed to the tsunami. The maximum runup/wave height was reported to be 2 to 3 m, and inundation and coastal flooding extended up to 100 m inland in some locations. Both coseismic coastal uplift and the presence of fringing offshore reefs appear to have provided protection against major runup effects in some coastal areas. Elsewhere, runup effects were amplified at river mouths due to differential compaction of unconsolidated sediments. Widespread tsunami sand deposition near the Costa Rica-Panama border in 1991 is similar to deposition ass

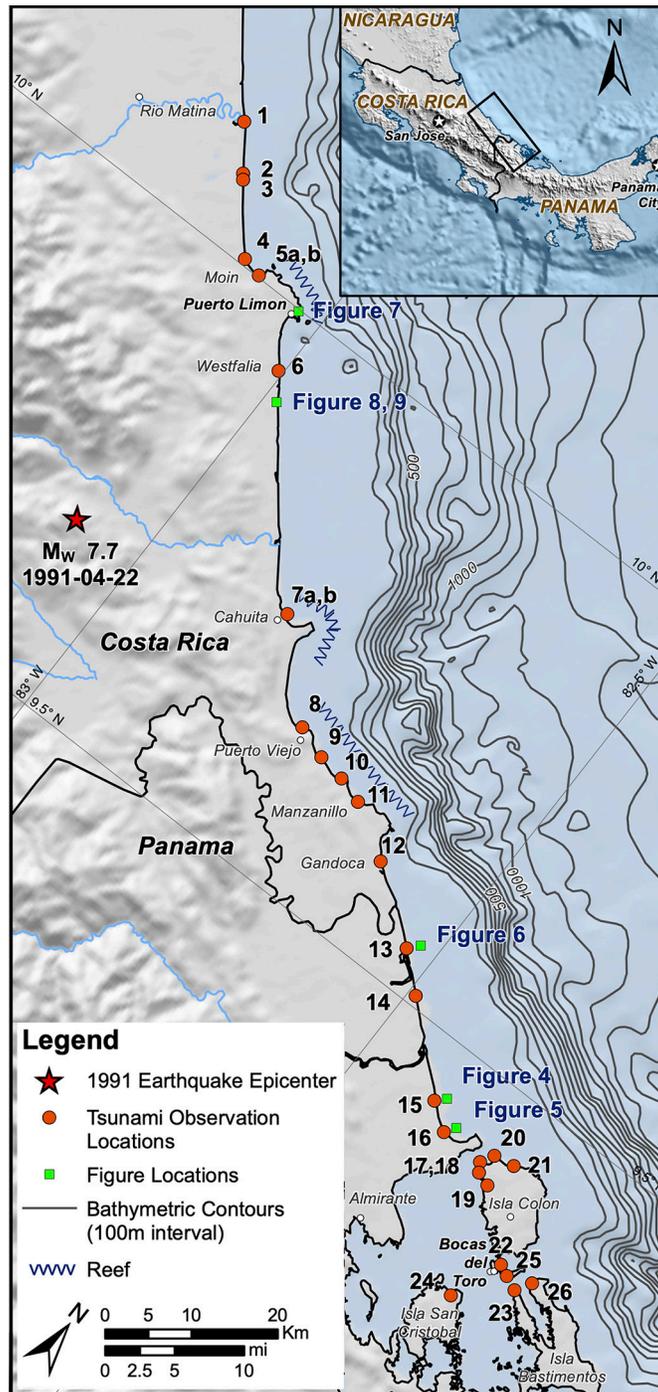
Fig. 1: Map showing locations of photographs (green squares) and questionnaire responses (red circles) collected in Costa Rica (sites 1 – 12) and Panama (sites 13 – 26) following the 22 April 1991 Limón, Costa Rica tsunami. 1991 Mw 7.7 earthquake epicenter is shown as a red star. Coastal coral reefs shown as jagged lines. Background topography and bathymetry from GEBCO Compilation Group (2020).

Eyewitness accounts of tsunami activity in Costa Rica and Panama following the 1991 Limón earthquake are summarized below. Figure 1 shows the survey site locations and Table 2 lists a summary of the questionnaire responses at those sites. Tsunami runup and coseismic uplift measurements from Plafker & Ward (1992) are also listed in Table 2 as a reference. This report supersedes an earlier, unpublished version (Nishenko et al., 1994) that has been referenced by O'Loughlin & Lander (2003) and the NGDC/WDS Global Historical Tsunami Database (2021). The survey information is also contained in a Google Earth KMZ file located in Appendix 2 of the Electronic Supplement.

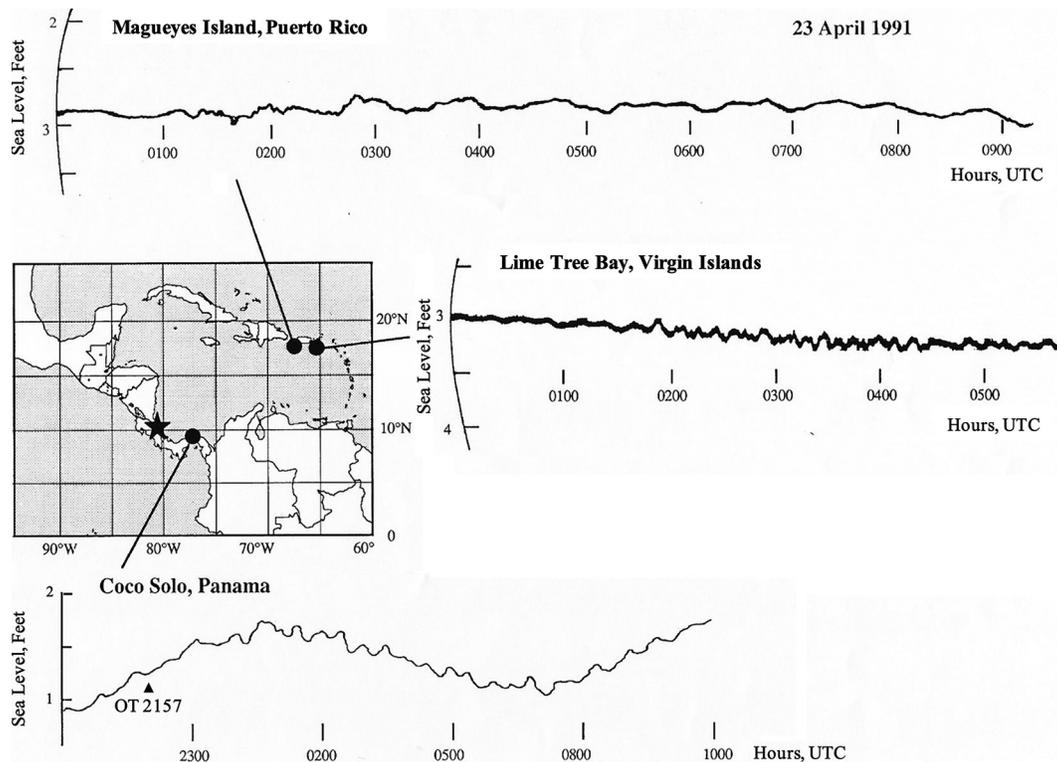
Fig. 2: Tide gauge records of the 1991 Limón, Costa Rica tsunami. Inset map shows the location of the tide gauges with respect to the epicenter (star). Vertical record scale in feet, horizontal scale in hours (Coordinated Universal Time, UTC). (a) Coco Solo (Cristobal) Panama [9.35° N, 79.92° W]. Earthquake Origin Time (2157 UTC) shown by arrow. Maximum peak to trough amplitude is approximately 3 in (7.6 cm); both (b) Magueyes Island, Puerto Rico [18.22°N, 67.16°W] and (c) Limetree Bay, St. Croix, Virgin Islands [17.69°N, 64.75°W] show maximum peak to trough amplitudes of ~ 3 in (7 cm).

A tsunami or series of waves with heights,  $h_{\max}$ , of 2 to 3 m were reported by eyewitnesses along the coast from Rio Matina, Costa Rica to Bastimentos Island, Panama following the earthquake (Fig. 1) indicating a tsunami magnitude,  $m$ , of ~1 (where  $m = \log_2 h_{\max}$ ; Table 1; Iida, Cox & Pararas-Carayannis, 1967; Iida, 1970). The Cristobal tide gauge at Coco Solo, Panama (9.35° N, 79.92° W, 320 km southeast of the source zone) recorded a maximum peak to trough amplitude of 7.6 cm (3 in) 1 hour after the earthquake (Fig. 2). Approximately 3½ hours later, bubbler tide gauges in Magueyes Island, Puerto Rico (18.22° N, 67.16° W) and Limetree Bay, St. Croix, Virgin Islands (17.69° N, 64.75° W) both recorded disturbances of about 7 cm peak to trough (Fig. 2). Appendix 1 in the Electronic Supplement contains copies of the three tide gauge records.

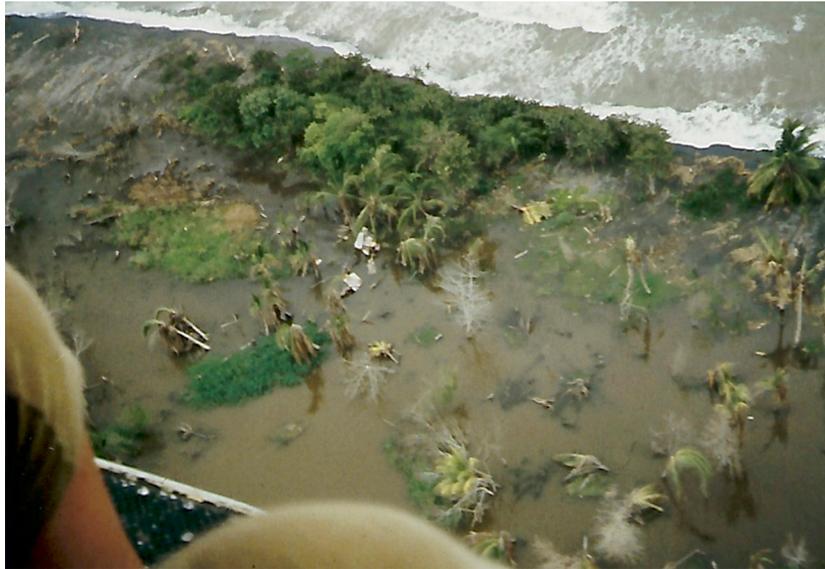
Fig. 4: Near vertical air photograph of an area flooded by the tsunami at Playa de Julio Abrego, Panama (site 15, Fig. 1). Note the onshore flooding and the NE-SW trend of fallen palm trees.

14		9.51°	82.49°				
15	Playa de Julio Abrego	9.43°	82.41°	A farmer reports that the before the quake occurred, the sea was very quiet. Minutes after the event the sea receded between three and six times. The last wave was the largest and the water penetrated 100 m inland. The NE-SW trend of fallen palm trees and other types of vegetation surrounded by sand and onshore flooding is seen in Fig. 4.			Beach
16	Changuinola River/ Tiri-bibi Pt.	9.42°	82.38°	Figure 5 shows the onshore flooding in this area and a zone of brown grass and vegetation parallel to the coastline. Sand deposition and fast currents			Beach

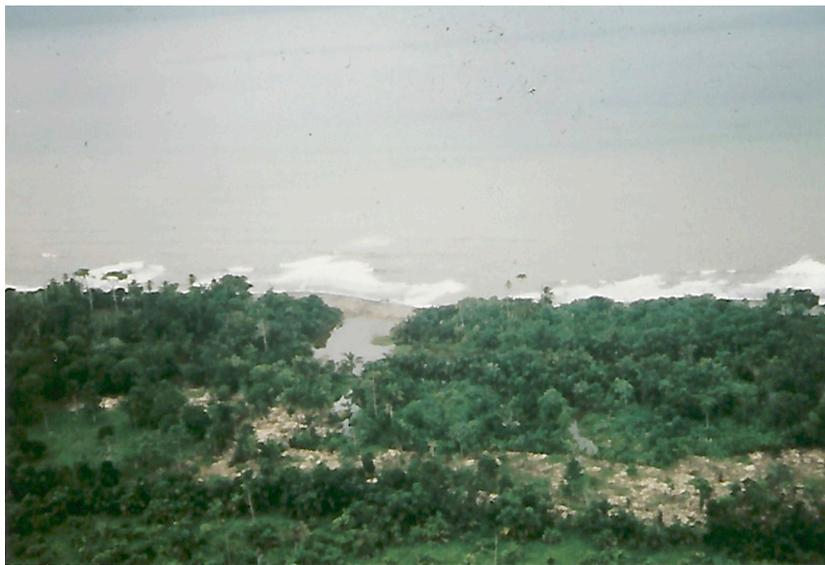
Fig. 5: Near vertical air photograph of an area inundated by the tsunami between the mouth of the Rio Changuinola and Tiribibi Point, Panama (site 16, Fig. 1). Note the onshore flooding in the center of the photograph and zone of brown vegetation in the lower portion of the photograph.

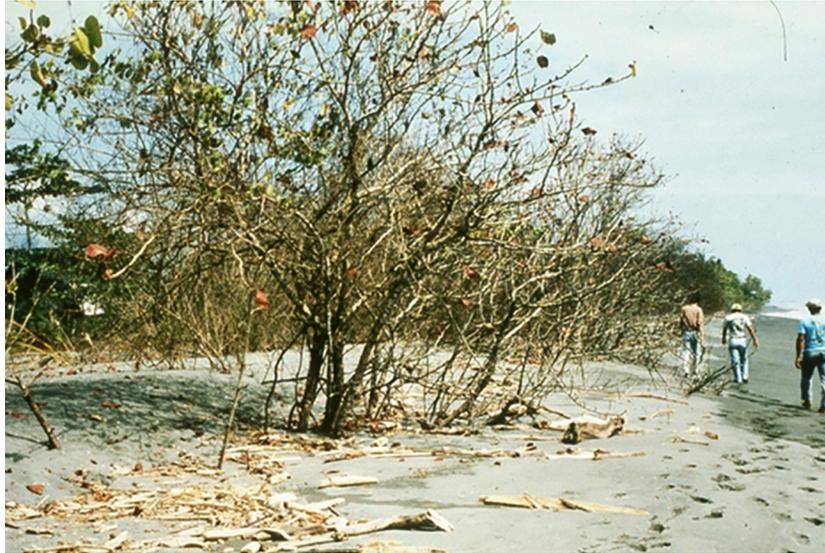
Fig. 6: Tsunami sand deposits on the beach at the San-San Natural Refuge, Panama (site 13, Fig. 1).

Following the initial retreat, two principal types of runup behavior were observed. The first consisted of a 2 to 3 m high wave which advanced rapidly to the beach. Runup varied according to location and ranged from 10 to 100+ m inland. This behavior was observed at the mouths of major rivers in the area, including Boca Matina (#1) and Bocas del Pantano (#2). Waves were noted to have overtopped 3 m high dikes at the mouth of the Moin River (#5) and penetrated 1 km upstream at the Estrella River (near #7). Widespread liquefaction along the coast and compaction-induced subsidence of poorly consolidated sediments appear to have locally amplified runup effects at the mouths of large rivers (EERI, 1991; Denyer et al., 1994). Large waves were noted along beaches at Puerto Viejo (#8), Punta Uva (SE sector) (#10), Manzanillo (#11), and Gandoca (#12). While no significant damage resulting from the runup was reported by observers, two drownings are reported to have occurred in the canal near Matina (#1) due to the sudden increase in water height. A third drowning has also been documented near Moin (Chacón-Barrantes, personal communication, 2021). Large waves and fast currents were also noted at sites facing the Caribbean in Bocas del Toro, Northwestern Panama. Onshore flooding was noted at Playa de Julio Abrego (#15, Fig. 4), Tiribibi Point (#16, Fig. 5), and Lime Point (#17). Elsewhere, observers described the water activity as a series of strong currents (West Knapp (#18), Ground Creek (#19) and Nancy Key (#23)). Sand deposition by the tsunami was also noted by the respondents at many locations (12 Millas de Moin (#3), Westfalia (#6), Manzanillo (#11), and Gandoca (#12)). At the San-San Natural Refuge (#13, #14), a layer of sand, approximately 1 m thick was deposited on the beach creating dunes and covering turtle nests (Fig. 6).

Information about the behavior of recent smaller tsunamis provides a valuable context for interpreting accounts of earlier Caribbean earthquake-related tsunamis. The deposition of sand near the mouth of the San-San River in 1991 is similar to descriptions of tsunami sand deposited on the coast near Gandoca and Monkey Point, near the Costa Rica-Panama border, during the 7 May 1822 ( $M_s$  7.5+) earthquake and tsunami (Roberts & Irving, 1827). Flooding was also noted to have occurred in bays and the mouths of rivers along the Caribbean coast of Costa Rica (González-Viquez, 1910). Farther east, the 7 September 1882 earthquake ( $M_s$  8.3), located in the North Panama Deformed Belt offshore of the San Blas coast of Northeastern Panama, created a tsunami with 2 to 3 m high waves, great destruction, and nearly 100 deaths on the islands of the San Blas archipelago. The French Panama Canal Company tide gauge near Colon recorded a maximum height of 62 cm (Viquez and Toral, 1986; Mendoza and Nishenko, 1989). The April 26, 1916 ( $M$  6.9) Almirante, Panama earthquake also created a small local tsunami that is reported to have covered the southern tip of Carenero Island in the Bocas del Toro Archipelago minutes after the event (Reid, 1917; Duda, Khattri, Purcaru & Schick, 1990).

7	Cahuita	9.74°	82.84°	The sea receded 75 m then returned slowly to a level lower than previous. Dead fish were observed.		38	Reefs
8	Puerto Viejo	9.66°	82.76°	The sea receded 100 m followed by a large wave, receded again and was followed by a large wave with 30 -70 m runup. Sand movement and dead fish were also noted.	155	38-45	Reefs
9	Final de Cocles	9.64°	82.72°	The sea receded 20 m then returned slowly over a 5 - 6 min period with no runup.		29-54	Beach and Cliffs
10	Punta Uva	9.64°	82.69°	Water retreats 400–600 m	200	40-45	Beach
11	Manzanillo	9.63°	82.66°	The sea receded 180 m and returned in 5 min to flood 30 to 70 m inland. Sand movement and 1.5 m sand mounds were deposited.	83-130	30-40	Beach
12	Gandoca	9.60°	82.60°	The sea receded 300 m in 5 min and returned to flood about 70 m inland. Sand Movement.	125	30-40	Beach
Panama							
13	San-San Natural Refuge	9.54°	82.53°	Tsunami waves deposited a great deal of sand on the beach near the mouth of the San-San River, a wildlife refuge near the Costa Rica border, creating dunes which covered numerous turtle nests with approximately 1 m of sand and caused a decrease in the number of newborn turtles (see Fig. 6).			Beach

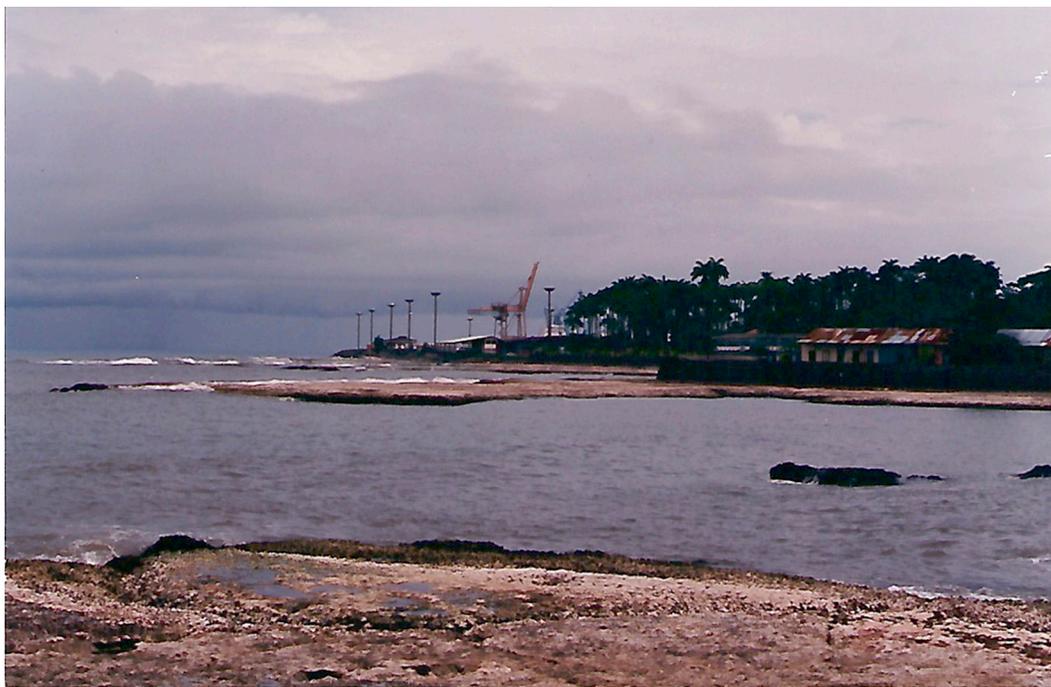
Fig. 7: Coseismic coastal uplift near Limón City, Costa Rica.

The second type of runup consisted of a gradual increase in water level without a large wave. In some locations, the sea returned an hour after the initial retreat. This behavior was noted both in areas that experienced coastal uplift (Moin (#5), Limon (Fig. 7), and Cahuita (#7)) and in areas surrounded by fringing reefs (Limón-Moin, Cahuita, Manzanillo, Puerto Viejo in Costa Rica, and Boca del Drago in Panama) which appear to have acted as natural wave barriers or breakwaters (Fig. 1). One observer in Cahuita noted that the water returned to a level that was lower than before the earthquake. The coseismic coastal uplift reported at Cahuita is 38 cm (Plafker & Ward, 1992). The maximum coseismic uplift offshore Cahuita (#7) and Manzanillo (#11) may be comparable to, or larger than, the uplift north and west of Limon (125-140 cm) based on measured tsunami runup heights (Plafker & Ward, 1992).

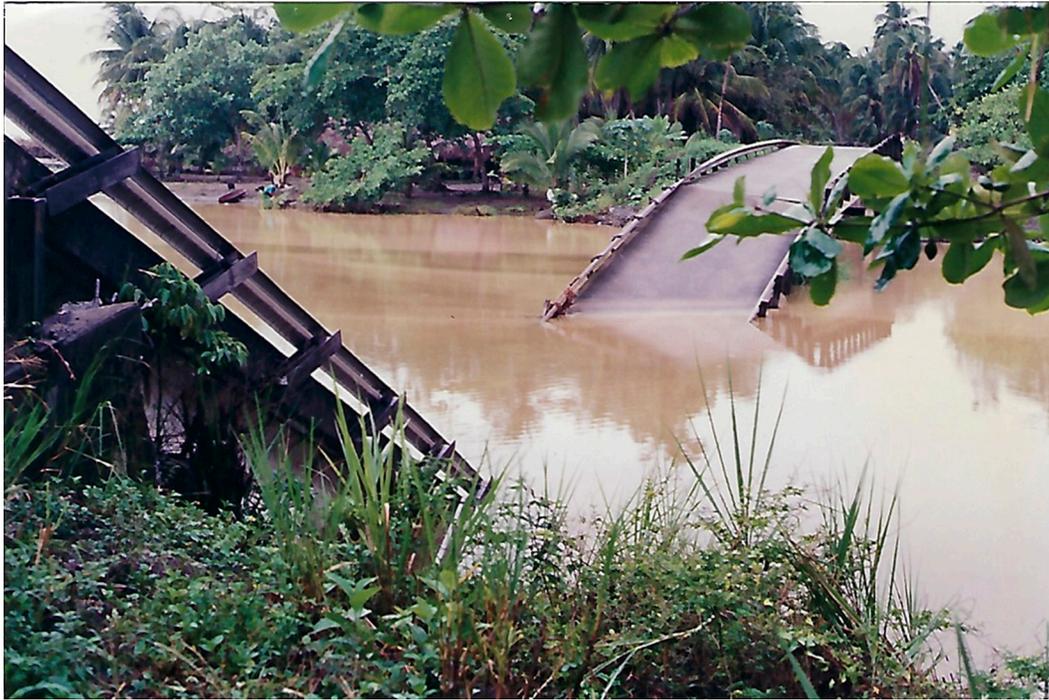
Fig. 8: Damage to the Vizcaya River bridge, 10 km south of Limón, due to soil liquefaction and lateral spreading.

The 1991 earthquake and tsunami demonstrated the vulnerability of the coastal region to strong ground shaking, coseismic uplift and flooding. Local communities and economies were affected by limited coastal access due to significant bridge and roadway damage (Figures 8 and 9; EERI, 1991). While little tsunami-related property damage was reported, two or more drownings occurred at the canal near Matina and near Moin. No emergency warnings were issued before the tsunami occurred. Preparedness programs can educate residents to run to higher elevations when they feel strong ground shaking along the coast – even in the absence of a siren or other warning.

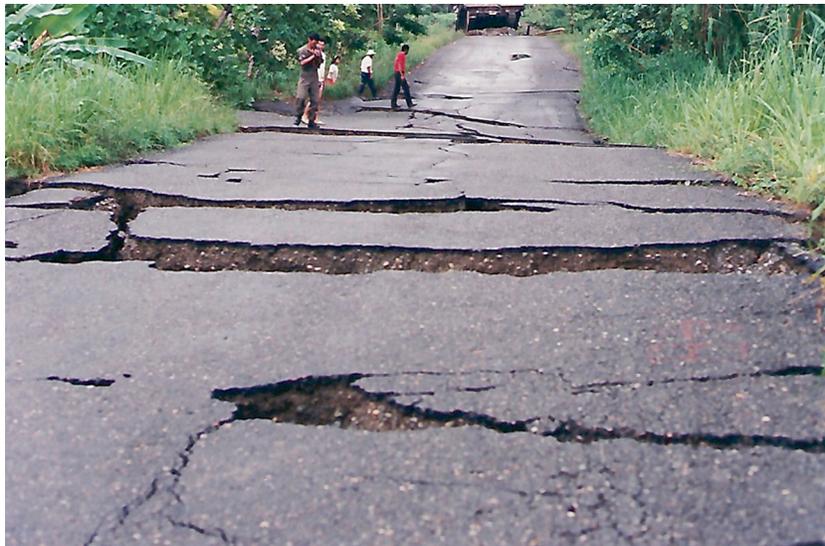
Fig. 9: Road damage on the Vizcaya River bridge approach due to liquefaction and lateral spreading.
