Groundwater management in an agro-industrial school in Argentina

The objective of this study was to analyze water quality for human consumption, hydrogeological features, water demand, and discharge of liquid effluents on soil and surface water.

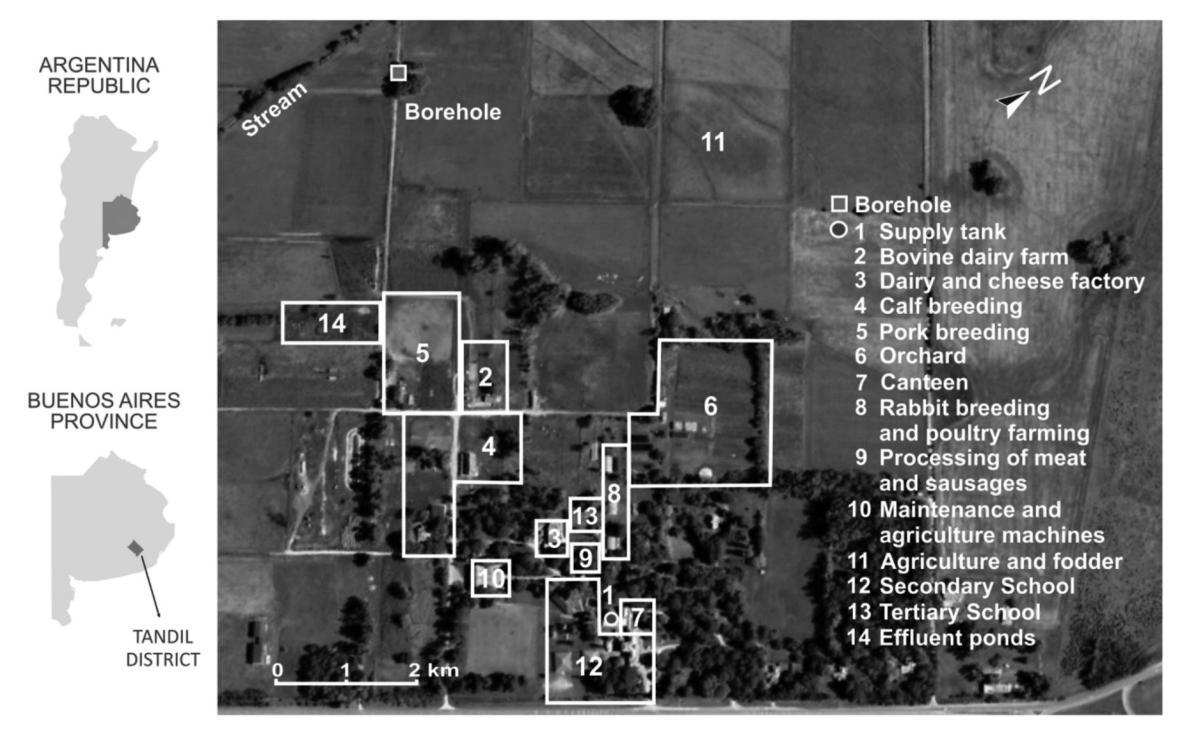
Fig. 1. Main productive sectors at the agro-industrial school studied.

Water demand: The water flow requirements (m^{3*}s⁻¹) were measured on each water supply device for six production sites of figure 1, selected as the main consumers (dairy farm, dairy and cheese factory, pork and calf breeding, orchard and canteen). The different activities taking place on each sector were registered in detail including its frequency, water sources employed, and effluent disposal modes. Then, the total daily and week-ly demands were calculated for each process via the corresponding time of scheduled activities. In the case

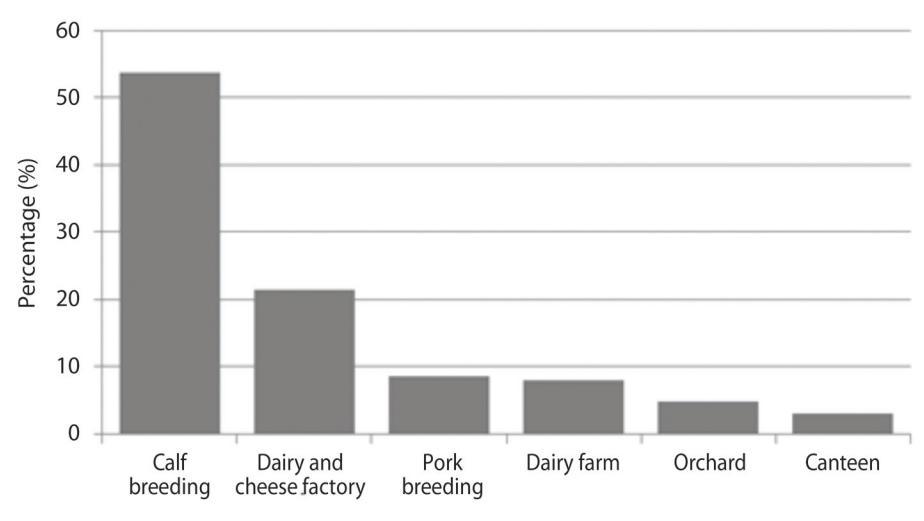
The distribution per sectors is shown in figure 2. The highest amount of water was consumed at the area devoted to calf breeding (~54%), followed by the dairy-cheese factory (~22%). In the former, water is mainly used for the process of milk cooling through a hose system working 24 hours/day, while, in the latter, water is mainly employed in a boiler and in the cleaning of floors/allowances.
